## REHABILITATION OF ANCIENT DIVERSION DAMS OF KOR RIVER IN FARS PROVINCE, IRAN

### ABSTRACT

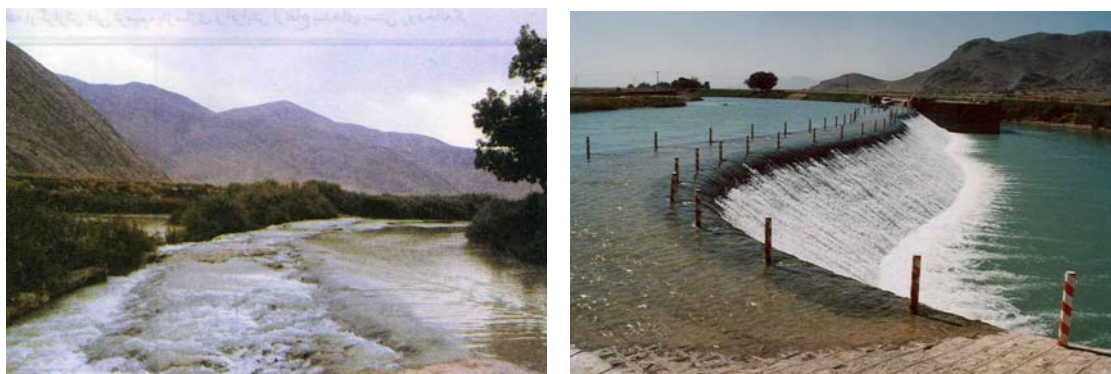
of the dam length is across the river width and the remaining dam length is constructed along the river (Fig 3). This is due to following reasons:

- The small width of the river and existence of watermills.
- Not enough spillway crest length to pass the flow at high discharges.

At the right bank of the dam there is one meter deep and 1.5 m wide canal. This canal was constructed on the spillway to convey water to downstream at low flows (discharge of less than 10 cubic meters per second). The dam becomes submerged at flows of  $90 \text{ m}^3\text{s}^{-1}$ . Full submergence occurs at discharge of  $150 \text{ m}^3\text{s}^{-1}$ . The average depth of water behind the dam was about 5.5 m. Before rehabilitation, the safety against overturning under earthquake condition was 2.7 and against sliding was 1.6 (Omran Zamin, 1983). Bearing capacity was calculated to be  $0.9 \text{ Kg/cm}^2$  under earthquake condition.

Under the above conditions safety factors were more than the allowable values. However, under earthquake condition safety factor against sliding was 1.3. Under this condition the bearing capacity was estimated to be between  $1.1$  to  $1.3 \text{ Kg/cm}^2$ . When the dam was considered to be fully submerged, safety factors were more than 1.7. Under normal conditions, safety factors against sliding and overturning were more than 2.0. Due to the existence of a 2m cutoff and 15 cm thick filter, the vertical exit gradient was calculated to be more than 3 that indicates the dam is safe.

**Figure3.** Feizabad dam before and after rehabilitation

Fig. 3 shows the pictures of this dam before and after rehabilitation.

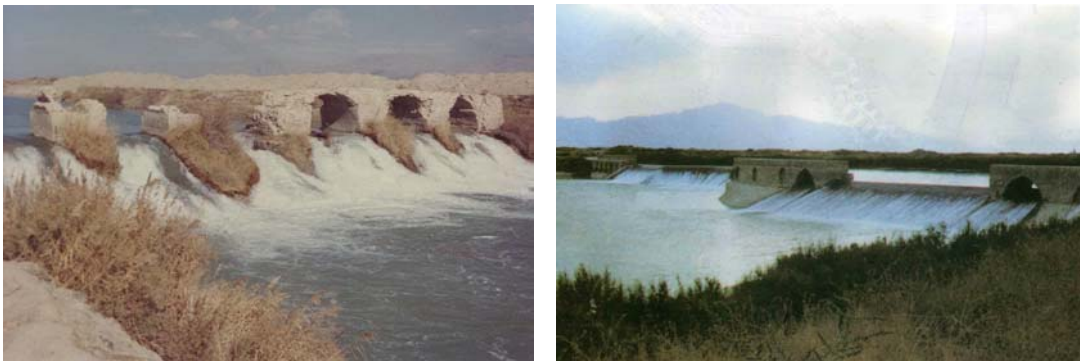
Tilakan dam is located at 14.5 km downstream of Feizabad dam. This dam is also a multipurpose one. The dam is submerged at a discharge of 80 cubic meters per second. However, when river flow reaches 230 m<sup>3</sup>/sec, the dam becomes fully submerged. The dam length was about 180 m with 34 openings of 1.7 to 3.5 m wide before rehabilitation. The safety factors against sliding and overturning under earthquake are 1.3 and 2.4 (Zand, 2005). The average dam height from river bed was about 5 m. Fig. 5 shows the dam before and after rehabilitation. Fig. 6 shows the earth canals excavated by the farmers for diversion of irrigation water before increasing the crest height of the dam. The command area before rehabilitation was 11000 ha, while it was increased to 12500 ha after rehabilitation.

The stability analysis after rehabilitation was under the same load conditions as Feizabad dam. However, the safety factors against sliding and overturning under earthquake condition (horizontal acceleration of 0.1 g) were 1.25 and 2.4 respectively. Maximum pressure on foundation was calculated to be 1.1 Kg/cm<sup>2</sup>. The Lane weighted creep ratio was 4.9 and shows that the dam is safe against piping on its silty clay foundation.

**Figure5.** Tilakan dam before and after rehabilitation

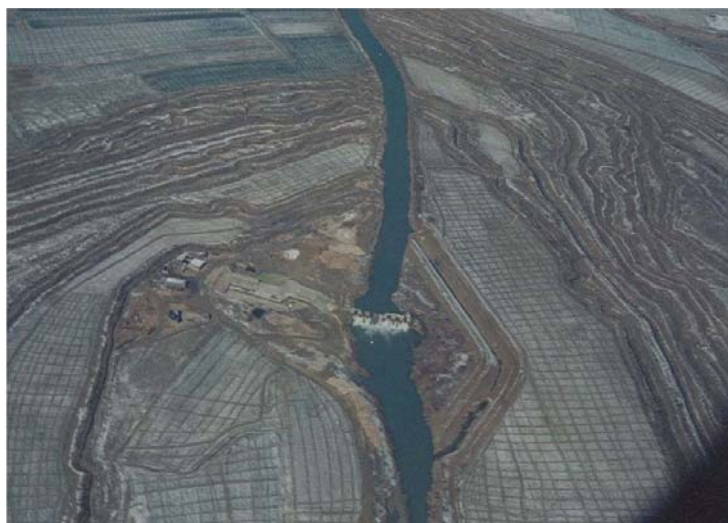
**Figure6.** Tilakan dam and the corresponding canals and farms before rehabilitation
